Many converting manufacturers use an extrusion drool tub to catch excess polymer from the extruder during a web break or change in material. During this time the extruder continues to run with the extrusion drool tub catching the excess polymer.

Challenge

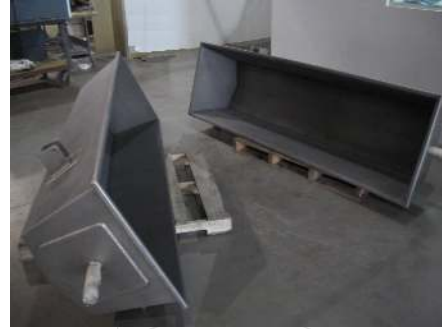
One customer with a laminating operation was having problems cleaning the drool tubs when they were full. It required hammers, axes, and pry bars to remove the cured polymer. This was time consuming, as well as dangerous; and required a great deal of employee labor.

American Roller's Plasma Coating Division coated the interior of the drool tub with a release coating, to facilitate easy cleaning. The tubs had been abused over the course of day-to-day operations so prior to the coating process the bowed sides of the tub were straightened and the corners were re-welded, for added strength and reinforcement.
